Greeter Falls Area Trail Improvement Program

Trail System Assessment

July, 2021

updated September, 2021

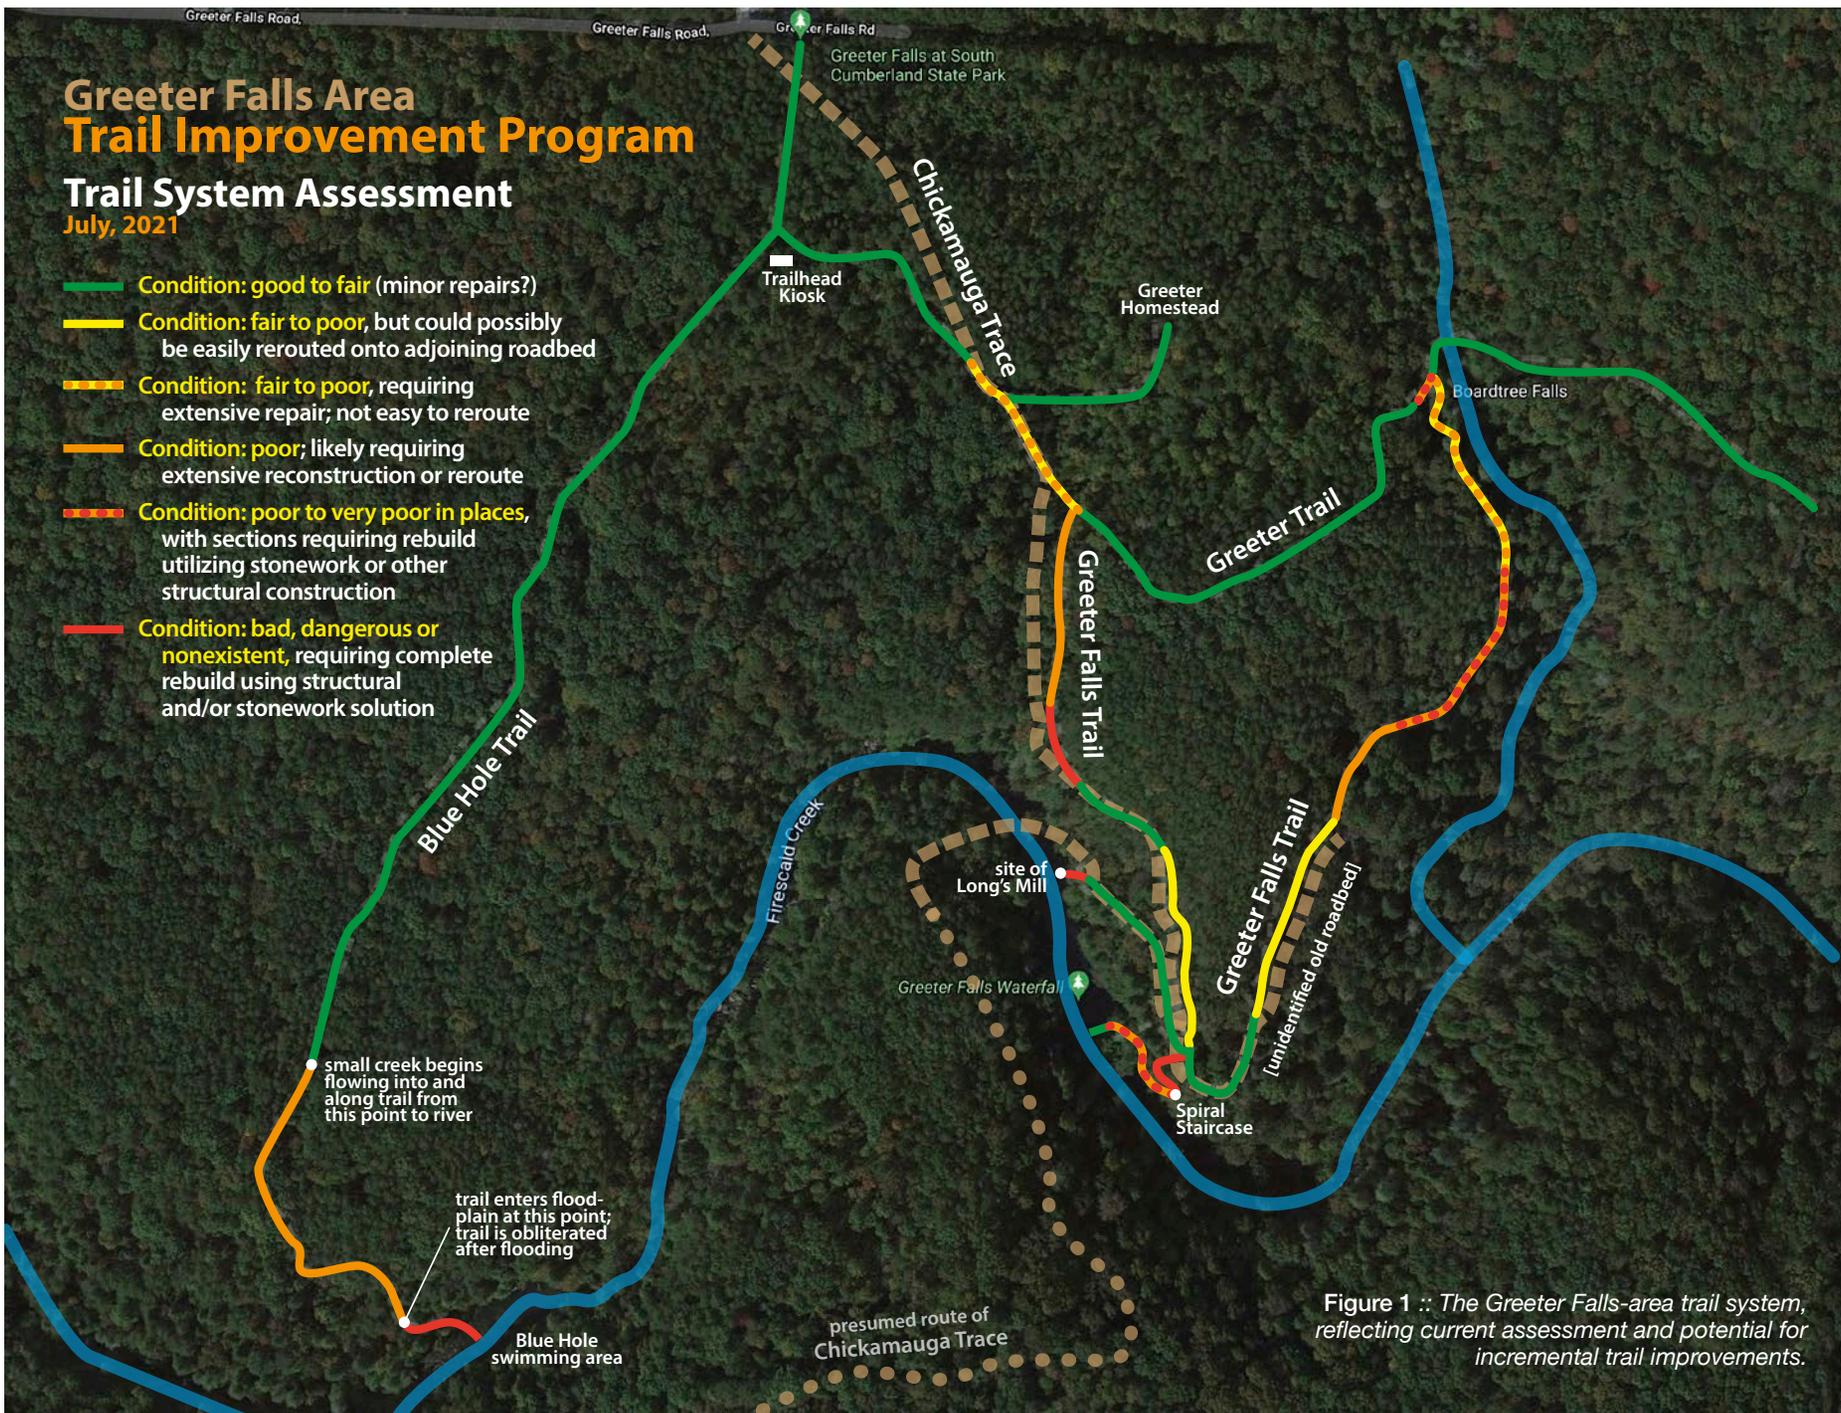
Figure 1 :: The Greeter Falls-area trail system, reflecting current assessment and potential for incremental trail improvements.

As a result of years of heavy visitor use, combined with topographic and soil conditions, nearly every trail in the study area shows some degree of degradation. As indicated in Figure 1, these trails have been assessed on a six-increment scale, ranging from “good to fair” down to “bad, dangerous or nonexistent”. These increments also suggest what degree of remediation might be necessary (or possible) to bring a trail segment from its existing state up to at least “good” condition.

Cumulatively, the amount of work needed to rehabilitate all of the degraded trail in the study area could be daunting. However, by breaking the work into smaller, incremental tasks, a series of projects could be created that would appeal to volunteers interested in seeing a project to completion over the course of a month or two, consisting of weekly work-days; similar to a method used on the Dog Hole Trail project, in the Fiery Gizzard, which was successfully completed in 2021.

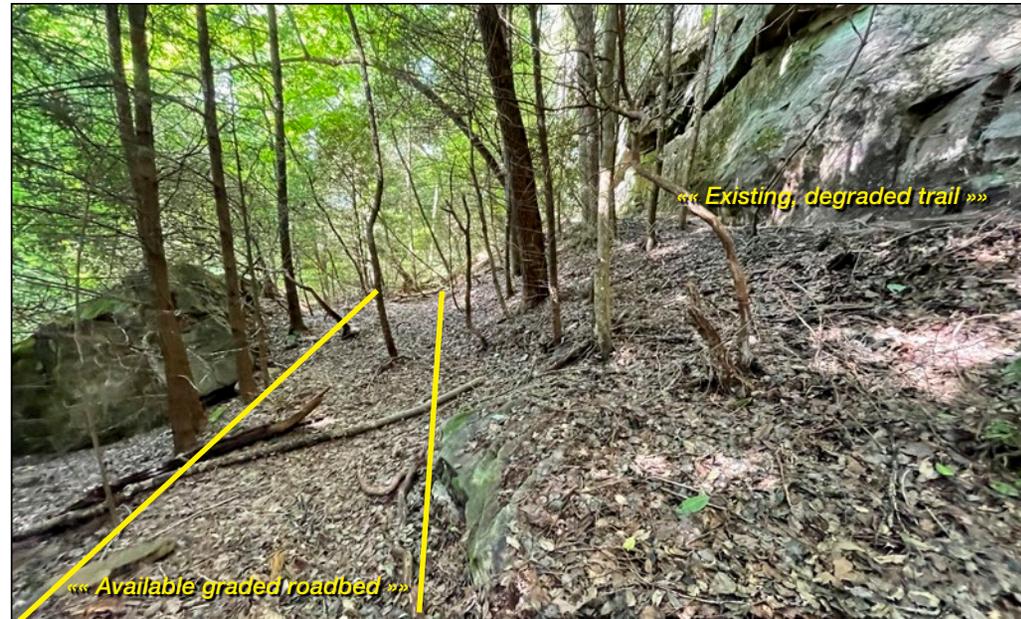
However, there may be an opportunity to efficiently bypass some of these difficult-to-remediate areas by making use of portions of the historic roadbeds, as there are several sections where old roadbed runs parallel to, and usually just downhill from existing trail (Figure 4).

Figure 4 :: Degraded sections of the Greeter Falls Trail hug the base of the bluff at right; the relatively clear roadbed, at left, may offer an excellent opportunity to quickly relocate the trail.

While there are often sustainability issues associated with running trails in old roadbeds, if the slope of the roadway is sufficiently shallow, these graded areas can allow for trail to be quickly reconstructed, with only a minimum of structural or stone work.

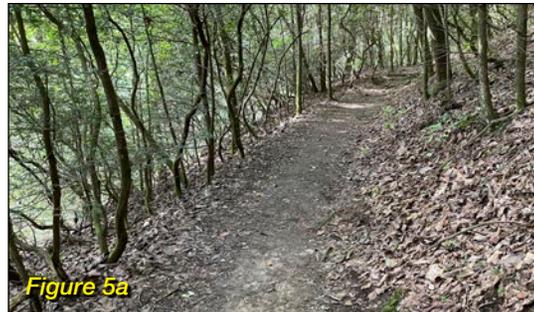
Figure 5a

In fact, other portions of the GFL Trail, which already utilize old roadbed, are still in excellent condition (Figure 5a, next page), as compared to trail constructed against the base of the bluff (Figures 5b&c, next page).

Figure 5 :: Portions of the GFL Trail which already utilize old roadbed, are still in excellent condition (*Figure 5a*), compared to trail constructed against the base of the bluff (*Figures 5b&c*)

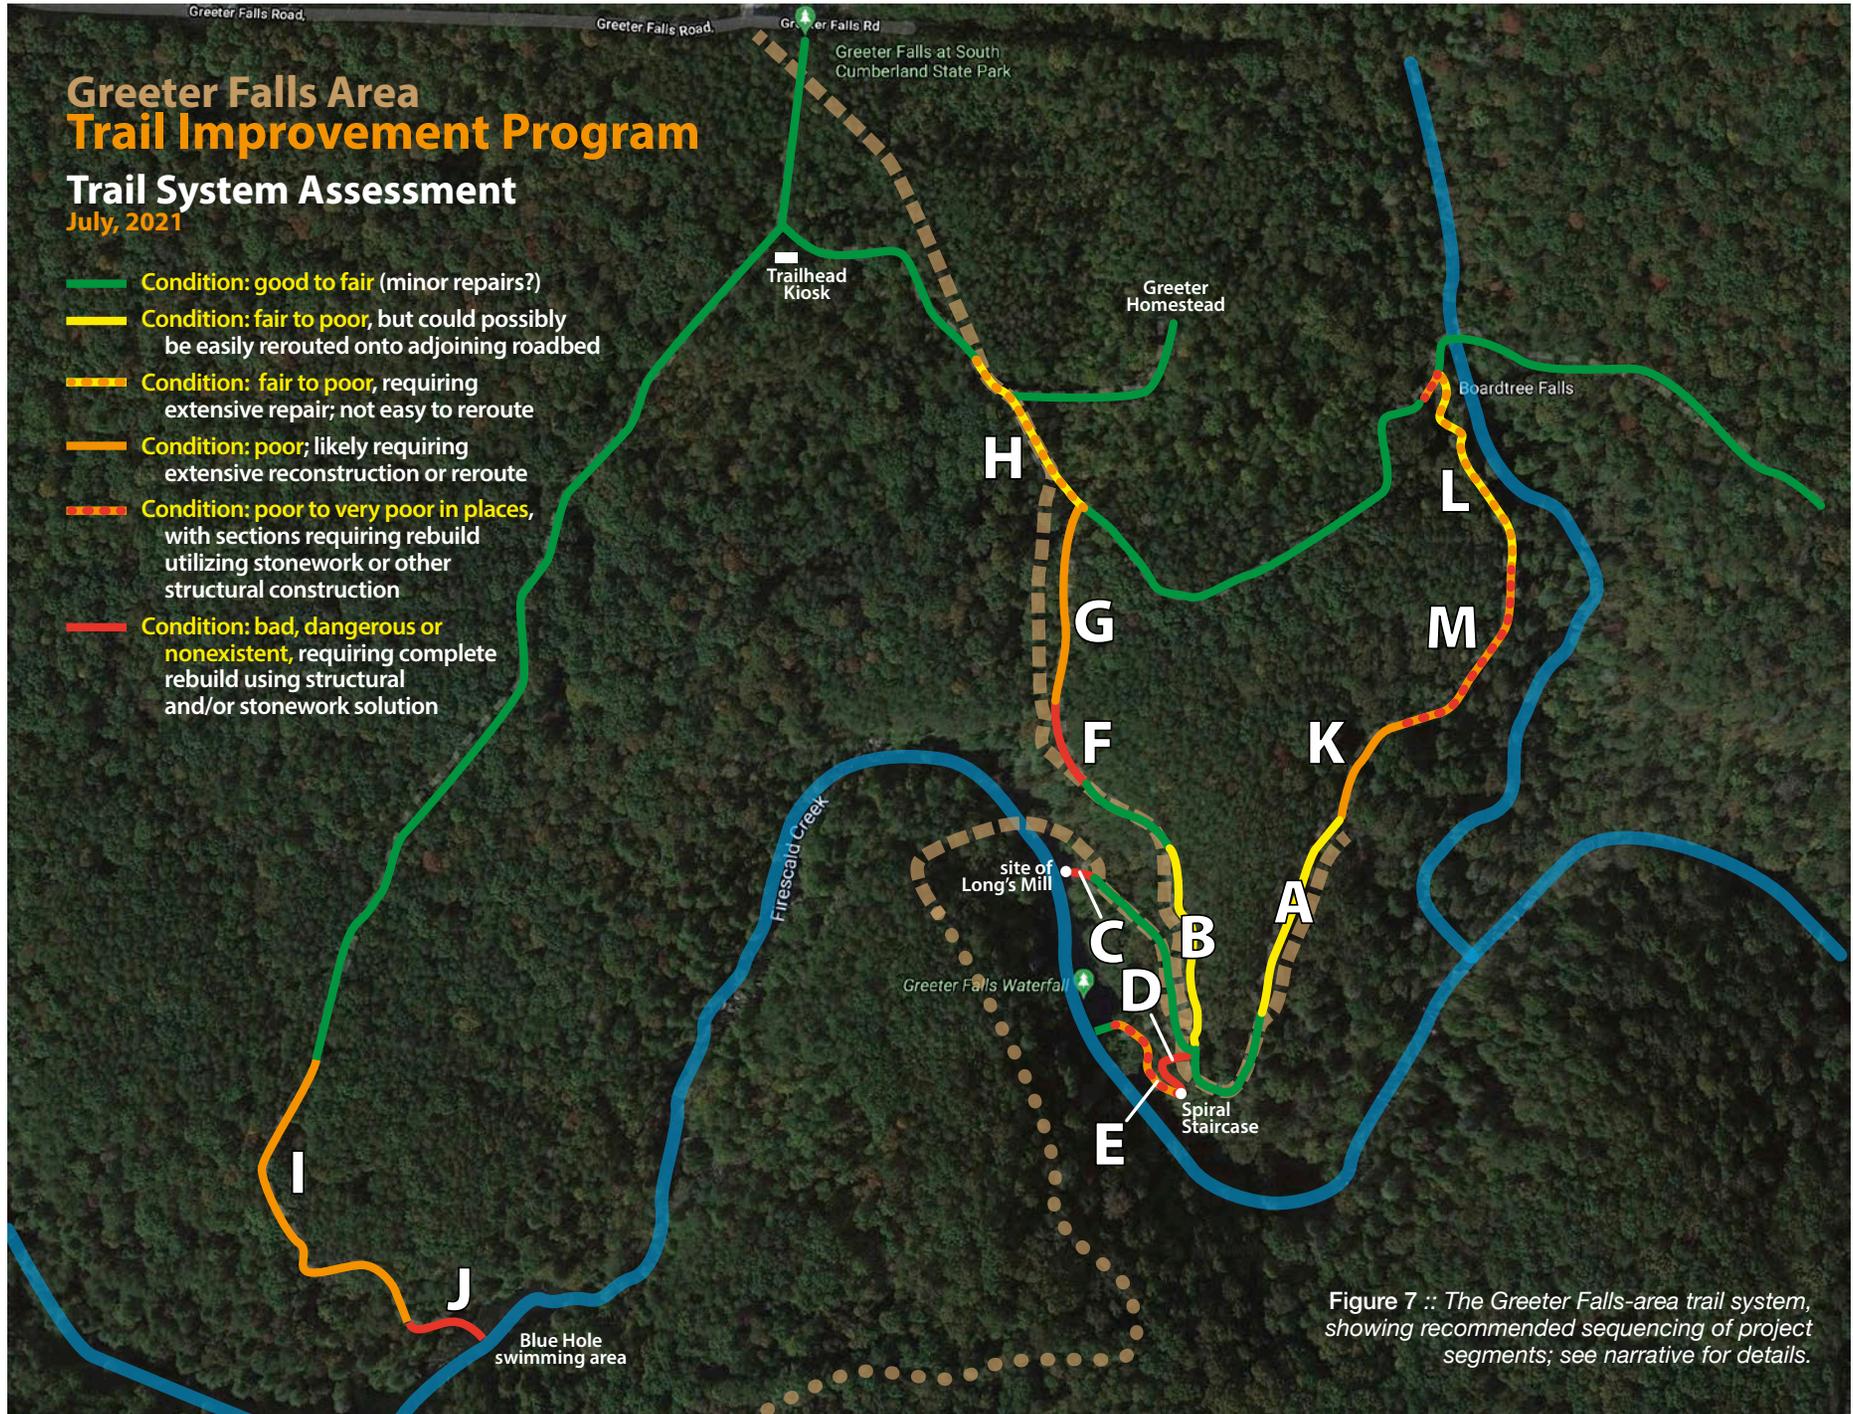
Figure 7 :: The Greeter Falls-area trail system, showing recommended sequencing of project segments; see narrative for details.

Figure 7, on the prior page, corresponds to the narrative that follows. Projects are presented in suggested chronological order. Timelines are generally conservative; strong volunteer turnout could accelerate completion of some segments.

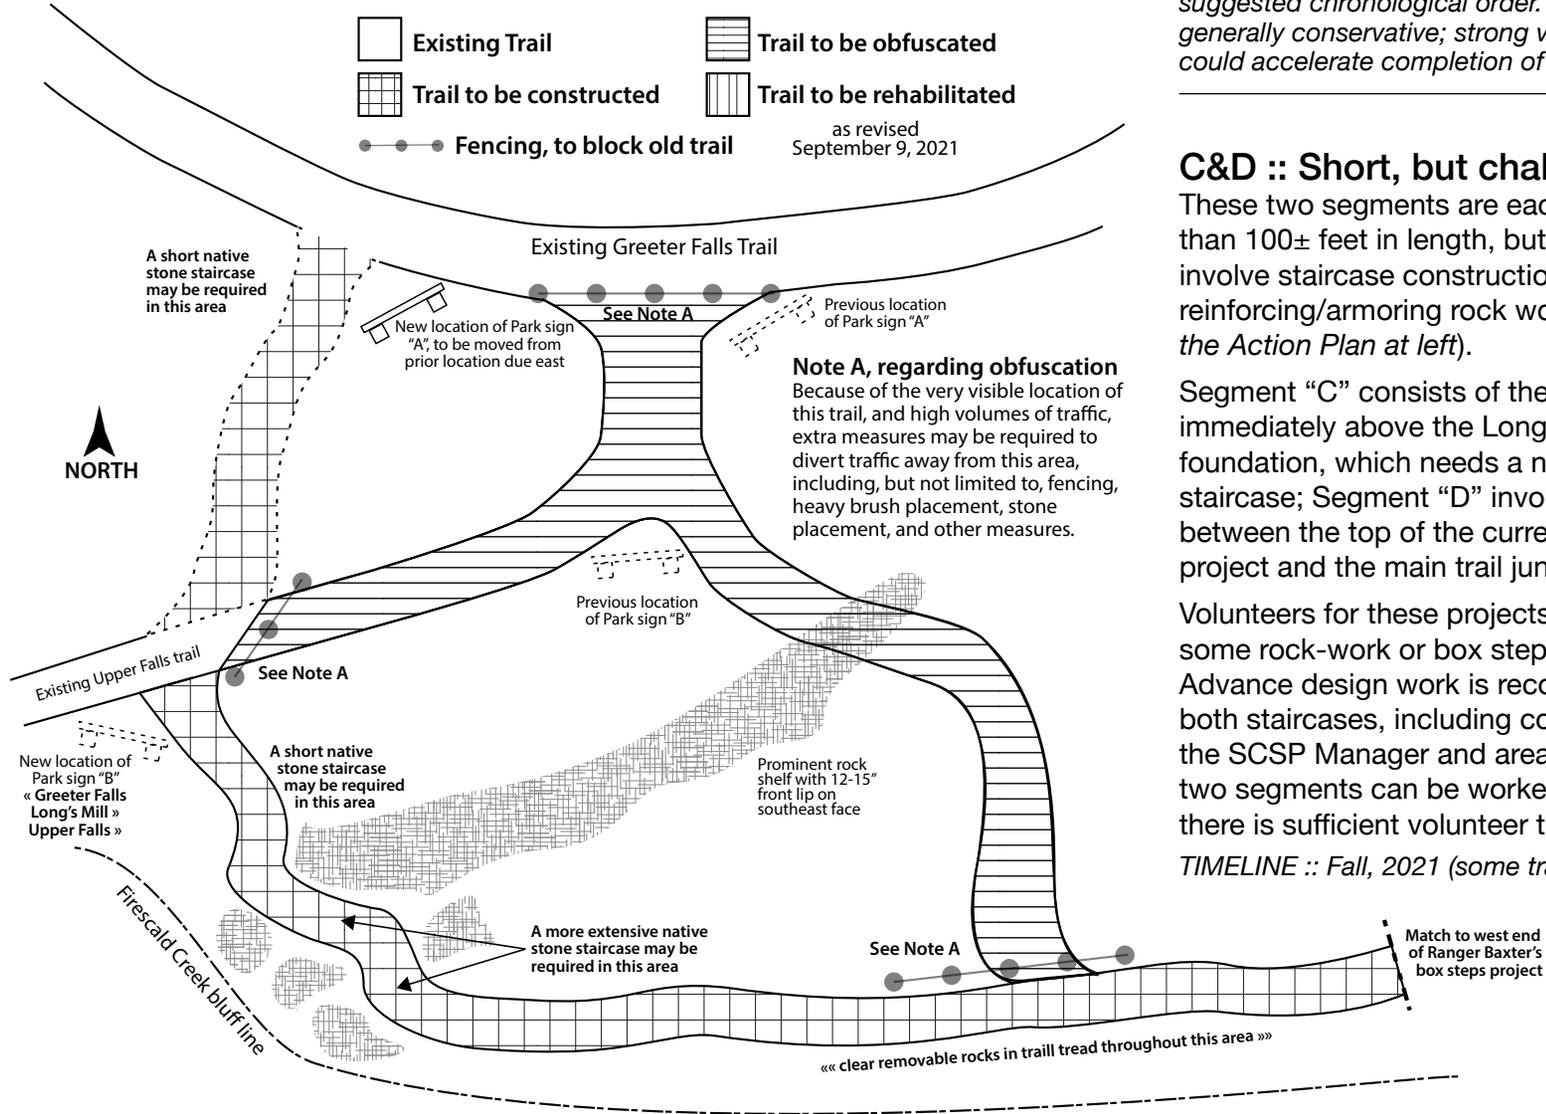
Greeter Falls Area Trail Improvement Program ("GFA-TIP")
ACTION PLAN FOR SECTION "D" REMEDIATION

Segment "C" consists of the area immediately above the Long's Mill foundation, which needs a new native stone staircase; Segment "D" involves the area between the top of the current box steps project and the main trail junction sign.

These two segments are each not more than 100± feet in length, but both will involve staircase construction and other reinforcing/armoring rock work (please see the Action Plan at left).

Volunteers for these projects should have some rock-work or box step experience. Advance design work is recommended for both staircases, including coordination with the SCSP Manager and area Ranger. These two segments can be worked together if there is sufficient volunteer turnout.

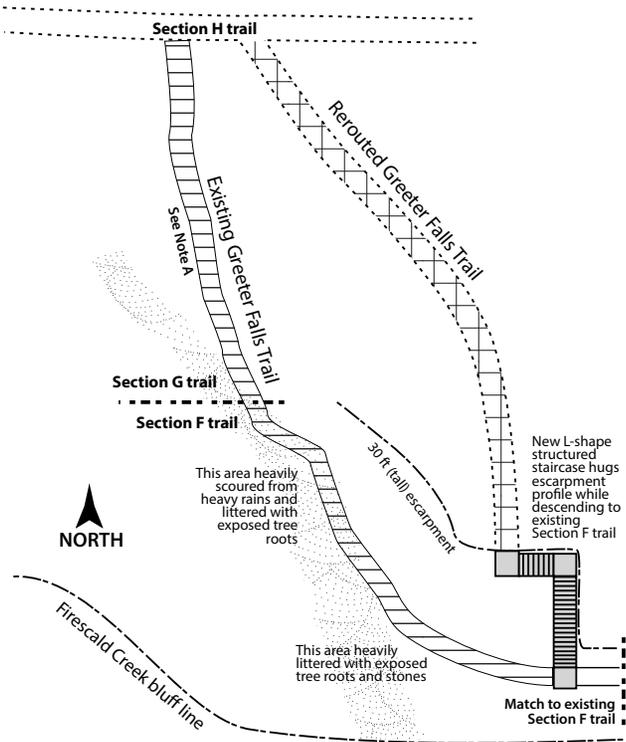
Greeter Falls Area
Trail Improvement Program ("GFA-TIP")
**ACTION PLAN FOR
SECTION F & G REMEDIATION**

Sections F and G involve rerouting a challenging section where the existing GFL Trail peels away from the Firescald Creek canyon and begins ascending toward its junction with the Greeter Trail. The current trail requires visitors to scale several large natural rock outcroppings. It is heavily worn and has captured the flow of a seasonal stream, making visitor travel slippery and hazardous in wetter seasons. The reroute would move the trail to the top of the ridge, just east of the current route (*Action Plan at left*); and reconnect to the trail at the south end of Segment F via a new, structured staircase (*Figures 8a and 8b, below*).

Note A, regarding obfuscation
Because of the very visible location of this trail, and high volumes of traffic, extra measures may be required to divert traffic away from this area, including, but not limited to, fencing, heavy brush placement, stone placement, and other measures.

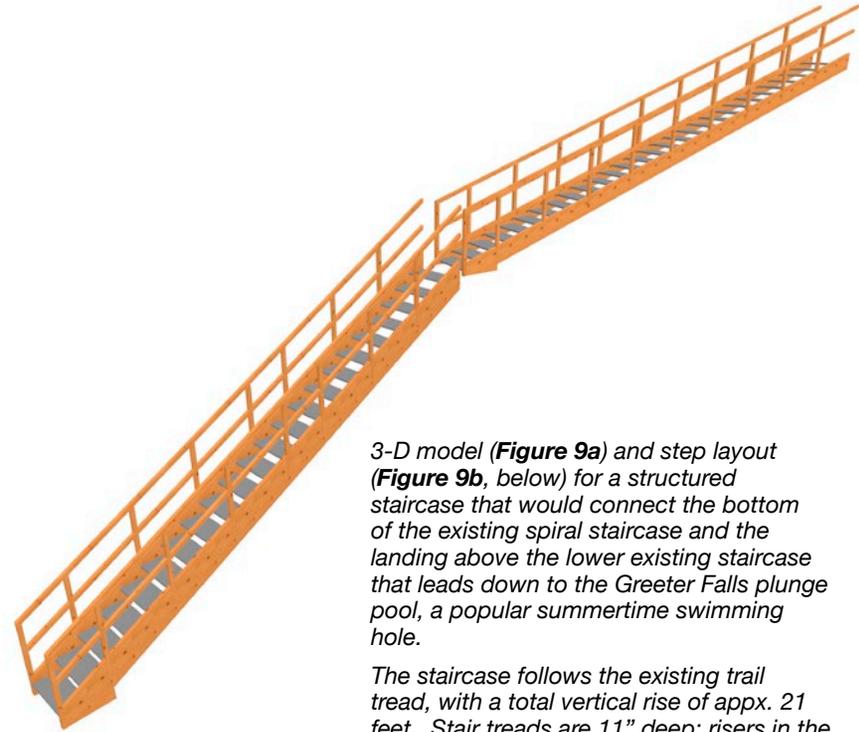
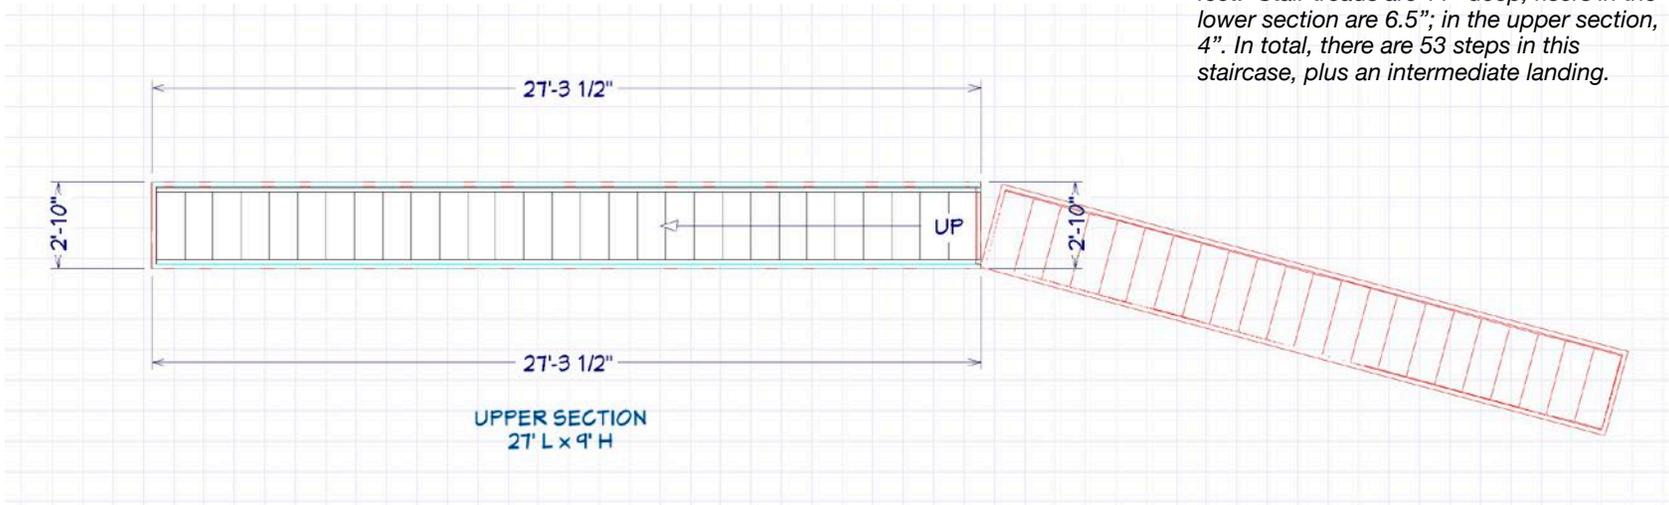
This segment echoes the box step work presently being done immediately above the spiral staircase; except that a structured staircase, constructed with grid-style metal treads (Figures 9a/9b), supported by pressure-treated stringers mounted on pressure-treated posts [sunk into the ground] would be used instead of box steps, both for reasons of utility (more durable/better in wet and icy weather), and because construction of this type of stairway would be significantly easier and faster than additional box steps. This segment, extending from the bottom of the spiral staircase to the top of the [existing] lower staircase, should be done either in fall or spring, outside of “swimming season” and peak visitation times. Winter ice would make work at that time of year inadvisable.

3-D model (Figure 9a) and step layout (Figure 9b, below) for a structured staircase that would connect the bottom of the existing spiral staircase and the landing above the lower existing staircase that leads down to the Greeter Falls plunge pool, a popular summertime swimming hole.

The staircase follows the existing trail tread, with a total vertical rise of appx. 21 feet. Stair treads are 11” deep; risers in the lower section are 6.5”; in the upper section, 4”. In total, there are 53 steps in this staircase, plus an intermediate landing.

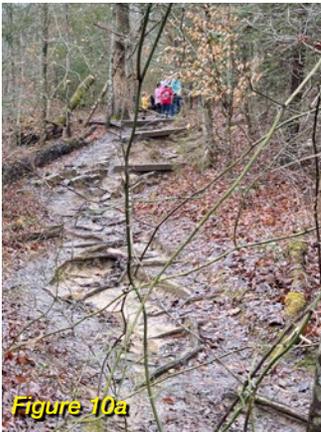
Figure 10a

Figure 10 :: Segments G (left) and H (right), both show signs of scouring from water using the trail tread as a sluice. Segment H is built on top of the historic Chickamauga Trace roadbed. If trail cannot be rerouted, some effort would be required to narrow the tread. The tread on Segment H is very wide, which may be encouraging the excessive runoff that is contributing to the significant volume of scouring.

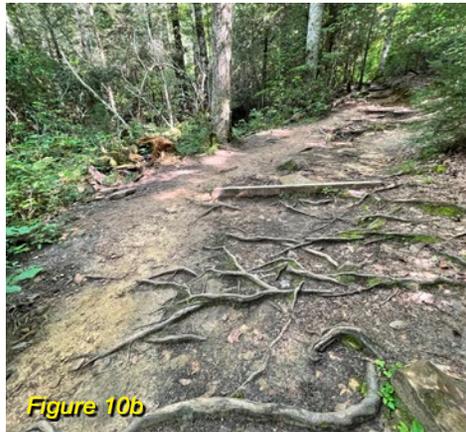
Figure 10b

Segment H is already running on top of old Chickamauga Trace roadbed, which has scoured down to bedrock in many, though not all places (*Figure 10*), leaving rock outcrops and roots exposed. This project would keep volunteer crews busy for several months. A great project for VISTAs, Scouts and other groups, alongside the Trails Team.

Design decisions for Segment H need to be made about whether to attempt to rehabilitate existing trail, or construct a new reroute alongside (or near) the existing route.

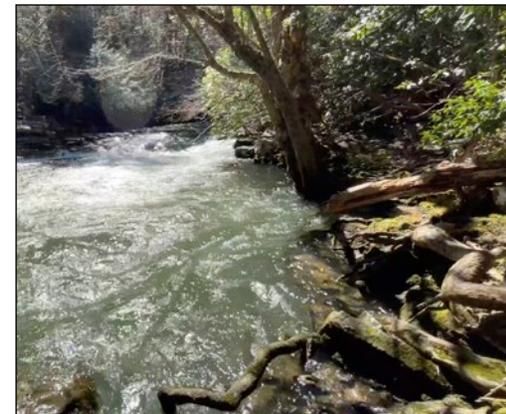
Project Segment J extends from where the existing stream/trail drops into the Firescald Creek floodplain, to the actual bank of the river – a distance of perhaps 100-150 feet. This area is subject to frequent flooding, and any sign of existing trail is obliterated, leading to the creation of multiple social trails during times of low water.

Figure 11 :: Firescald Creek at high water; trail terminus is just to the right. The floodplain area, also to the right, is indicative of the terrain through which Segment J would need to be constructed.

Perhaps the best approach for dealing with this segment is to define the trail by creating stepping-stones and/or twin strands of rock armoring, to define the trail for the visitor. Obviously, the rock used for these purposes will need to be large stones, not likely to be swept downstream during times of high water (*Figure 11*).

There will also need to be some stone staircase work where the trail drops into the floodplain, depending on exactly where the reroute makes that descent.

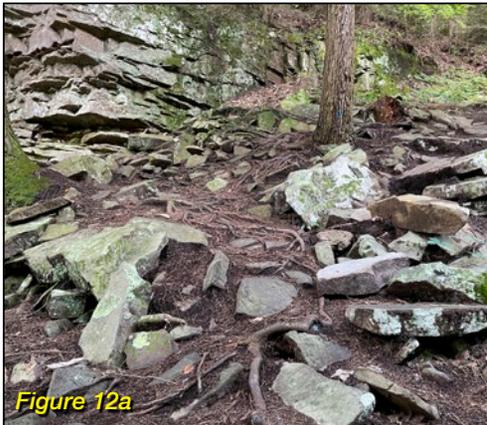
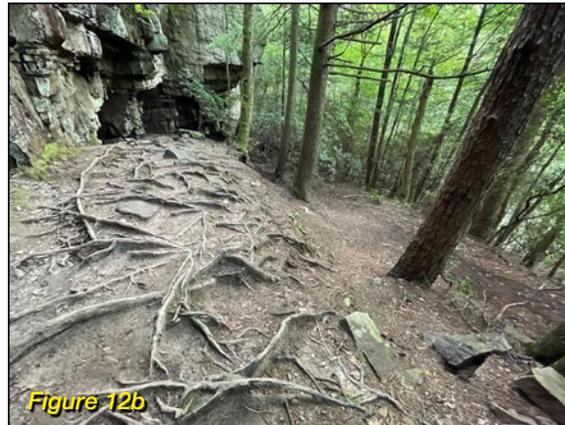
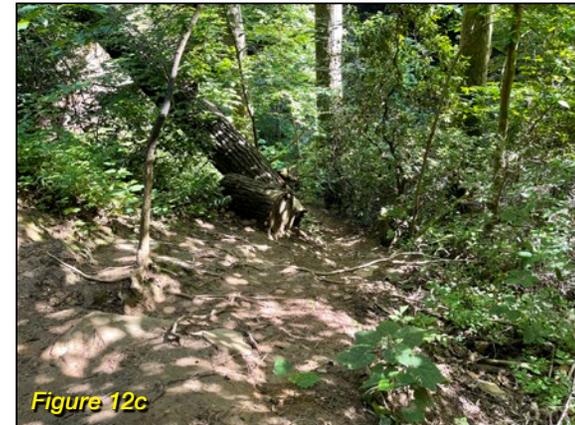
Nevertheless, existing trail tread exhibits signs of significant use, and many social trails have been formed to avoid areas where existing trail has degraded, exposing many rocks and roots. These segments of the trail appear to have been originally designed with the intent of staying as close to the base of the bluff as possible; thus putting much of each segment in areas with the most rock-fall material (*Figure 12*).

Figure 12 :: *At left, typical section of existing Greeter Falls Trail at the base of the bluff. At center, a view from existing trail near the junction of Segments A and K (existing trail at left, on roots); showing how a social trail has been created on a portion of the old roadbed, in an attempt to avoid the roots. Where roadbed can be found, it is typically nearby (within 30-50 feet of existing trail). At right, a heavily-worn social trail, created to access the base of Lower Boardtree Falls. Because visitors invariably want to “get to the waterfalls,” it may be prudent to “legitimize” social trails such as these, by rebuilding them with more sustainable design features, such as stone staircases and/or raised landings. There are at least three of these heavily-used social trails at various points in the Boardtree Falls canyon, not only at the the lower falls, but also at Upper Boardtree Falls, and at a smaller, unnamed falls in the middle of the Boardtree canyon. These potential spur-trails are not shown on Figures 1 or 7, but should be addressed at the same time as their adjacent Project Segments.*

For Segments K and M, there are opportunities to reroute the trail, a bit further downhill and away from degraded trail tread below the bluff.

However, for Segment L, reroute options are limited, as the terrain drops off steeply into the Boardtree Falls canyon; thus, a rebuild-in-place, with significant box steps or stone work, is more likely here. There is also a need for new stone steps just above the junction of the Greeter Trail with the GFL, to replace a series of washed-out water bars.
