Greeter Falls Area Trail Improvement Program

Trail System Assessment

July, 2021

updated September, 2021

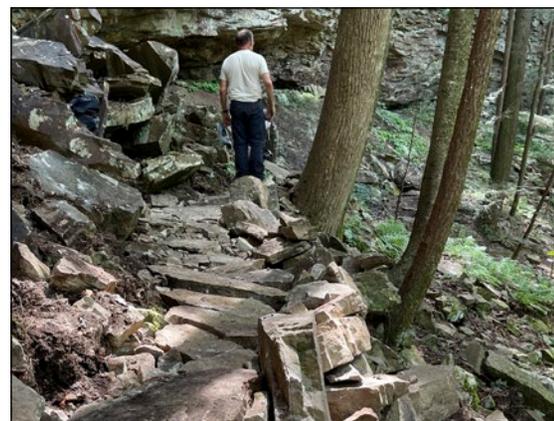
Figure 6 :: Armored trail and trail tread on the Dog Hole Trail, similar to what may be required on sections of the Greeter Falls Trail.

In some cases, there are sections, usually at the base of bluff-lines, where reroute is not possible *and* where there is significant tumble-down rock that has collected at the base of the bluff. Here, reconstruction will require the creation of extended stone-works, similar to those created for the Dog Hole Trail rehabilitation (*Figure 6*) for trail tread, armoring, and reinforcing retaining walls along the trail route.
